Hurricane Ike along the upper Texas coast: An introduction

Nicholas C. Kraus, Ph.D., and Lihwa Lin, Ph.D.

U.S. Army Engineer Research and Development Center,
Coastal and Hydraulics Laboratory, 3909 Halls Ferry Rd., Vicksburg, MS 39180
Nicholas.C.Kraus@usace.army.mil

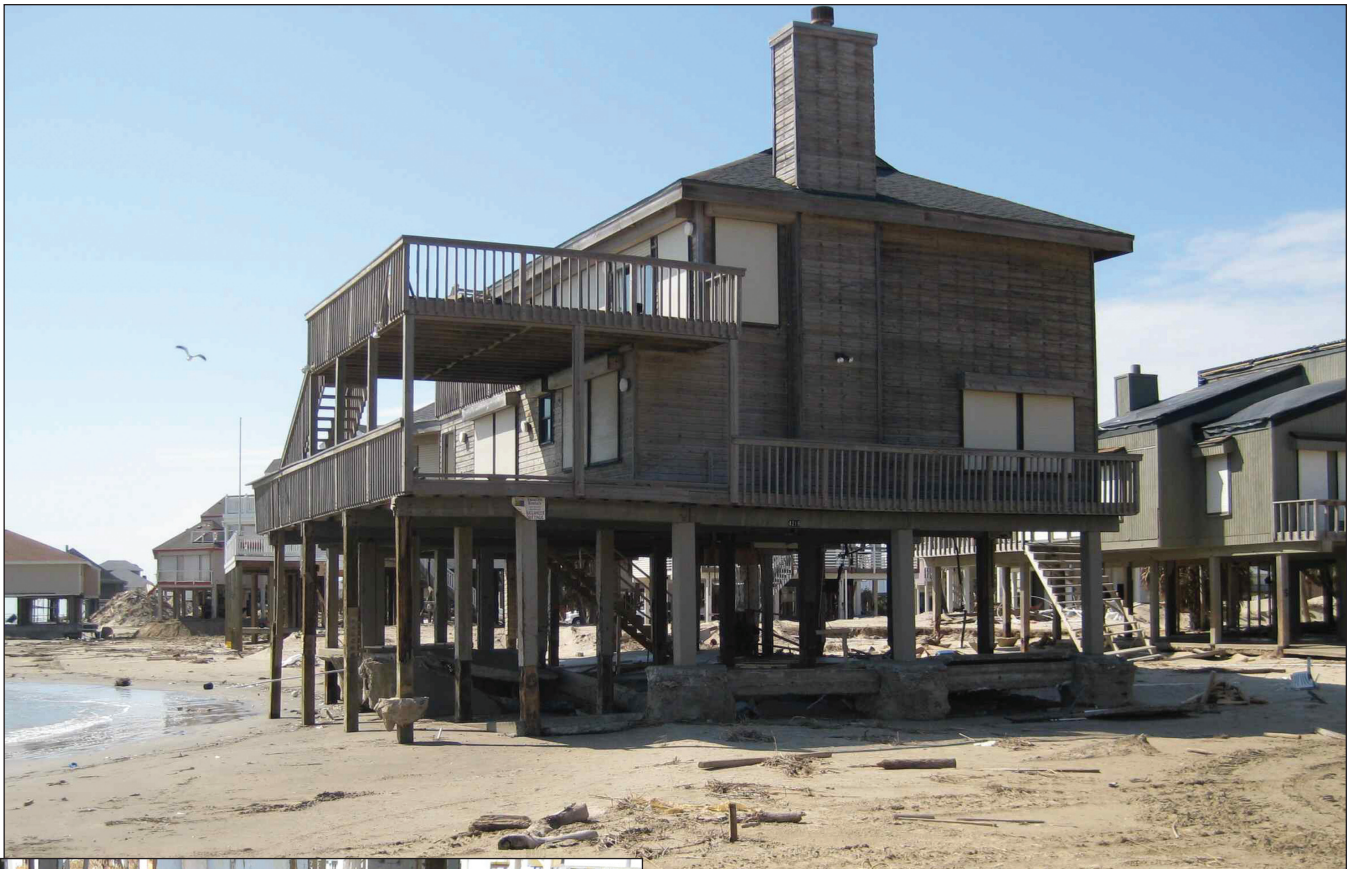
Figure 6 (above). Undermining of concrete slabs was progressively less with distance landward (to right of picture).

On 23 October 2008, the first author inspected the beaches west of the city of Galveston. Almost all residences and buildings gulfward of the Blue Water Highway are on pilings. Blue Water Highway is a scenic coastal drive (connecting to Farm-to-Market Road 3005) that runs some 40 miles (64 km) from Seawall Boulevard in the city of Galveston to Surfside Village in Brazoria County. Structures on pilings fared well under the long duration of extreme water level, surge, and waves. However, the concrete slabs under the buildings closest to the beach were extensively undermined (Figure 5). Damage by erosion was progressively less with distance landward from the beach (Figure 6).

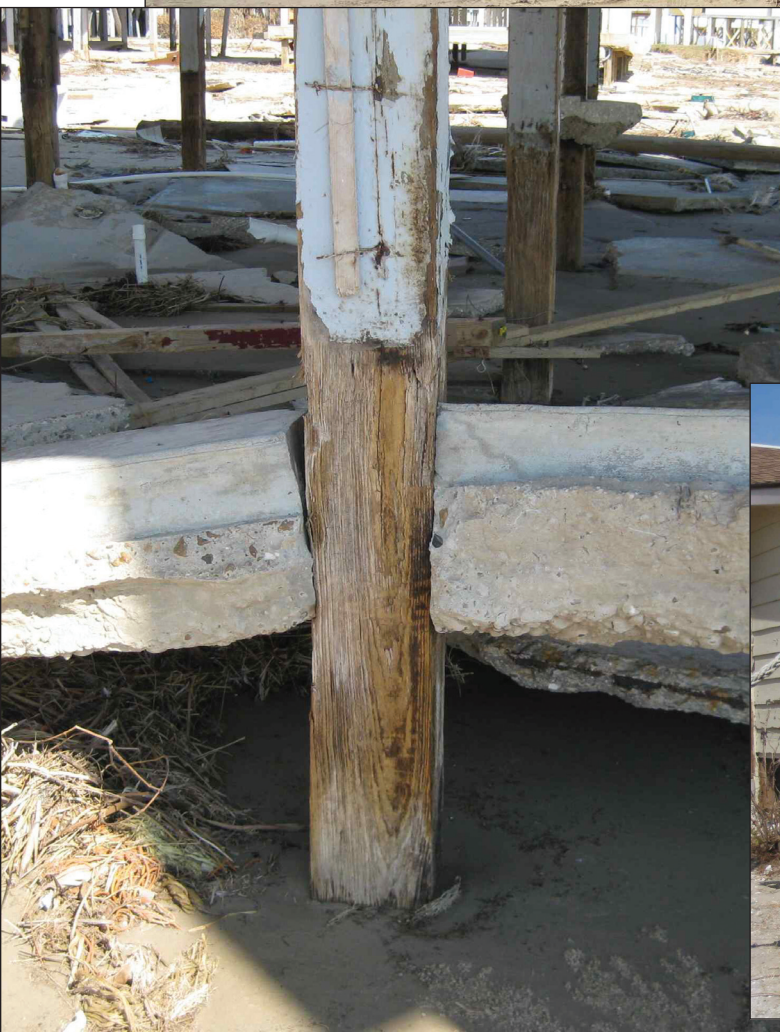
Figure 7 (left). Up and down movement of heavy concrete slab by the surge current and waves scraped this large piling, rounding and weakening it from its original square shape.

Buildings near the beach are inferred to have been damaged primarily by erosion induced by surge and waves, which undermined the massive concrete slabs under them. Some slabs were moved energetically by waves and the flooding current from the sea to bay, as seen in Figure 7. This photograph indicates that the slab was repeatedly moved up and down by hydrodynamic forces. Such movement stressed the pilings, tilted the structure, and caused damage that otherwise might not have occurred. Concrete slabs are constructed primarily for parking beneath the main dwelling and to serve as a foundation for large appliances and water heaters. A conclusion is that concrete slabs should not be placed under structures built on pilings that may be exposed to surge and waves. A gravel layer on top of filter cloth might be an appropriate and low-cost alternative.

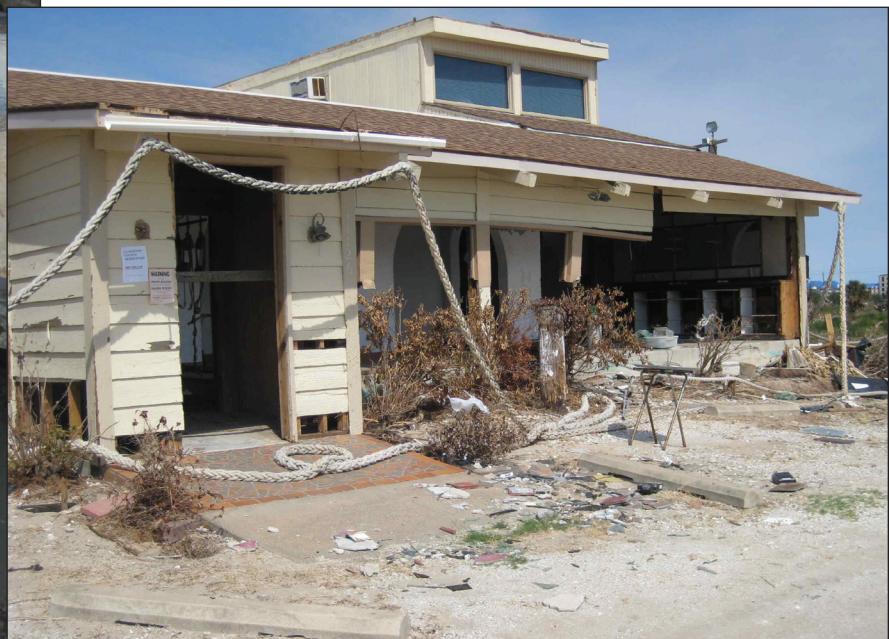
Figure 8 (below). Flood damage by surge on structure facing the Gulf of Mexico, but more than 1,500 ft (450 m) from the beach.

Older structures not on pilings were heavily damaged by the surge. The picture in Figure 8 shows such a structure, a restaurant located on the bay (north) side of FM 3005, some 1,500 ft (450 m) from the beach. Debris was driven into the building by the surge from the Gulf of Mexico and its functionality as a restaurant was destroyed.
